Premier Property Inspections

Pre Inspection
809 Linden St
Northfield , MN 55057

Date of Inspection: 2/18/2022

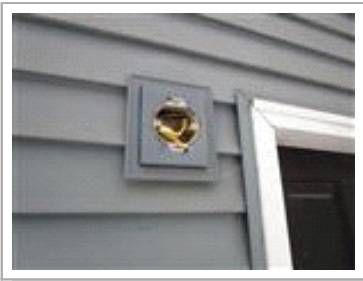
Figure Number 1

Light fixture located in the rear of home was missing.

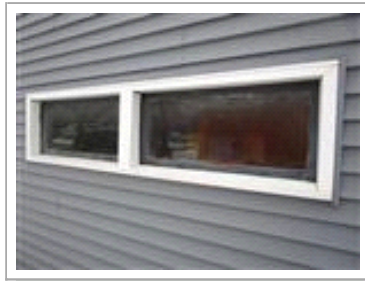
Figure Number 2

Some of the windows located on the main floor and garage are older and showing some signs of age via deterioration.

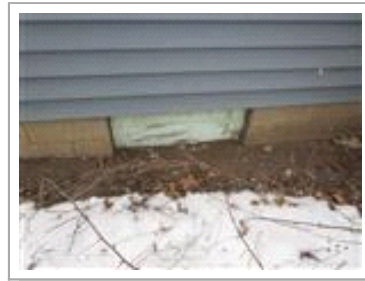
Figure Number 3

Basement windows located on the north side of home were insulated with foam board on the exterior of home.

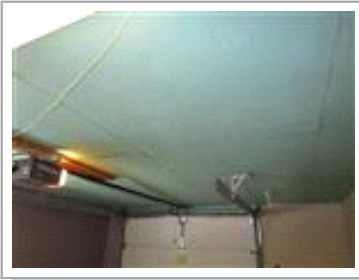
Figure Number 4

Walls that are shared with the home and garage should be covered in 5/8 drywall and taped, this is for fire and carbon monoxide protection.

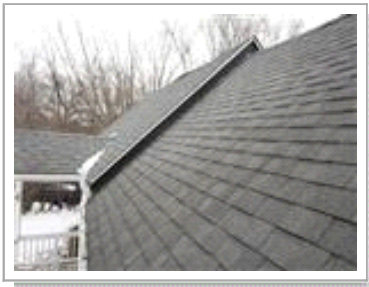
Figure Number 12

Roofing material is approximately 16 years old and was in acceptable condition overall related age.

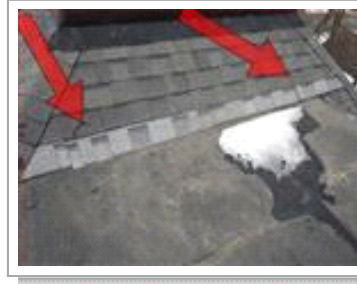
Figure Number 17

Evidence of newer repairs were found on rear of roof via newer shingles. Moreover some of the rubber membrane was loose at corners needing to be re-secured with adhesive.

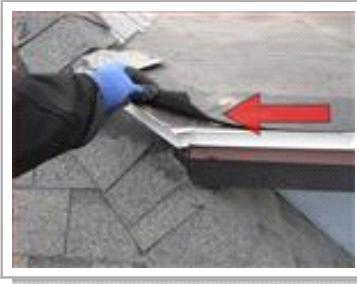
Figure Number 18

Evidence of newer repairs were found on rear of roof via newer shingles. Moreover some of the rubber membrane was loose at corners needing to be re-secured with adhesive.

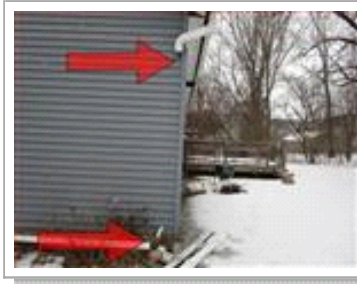
Figure Number 19

- I GUTTER- Down spout located on the SE corner of home was off/disconnected and laying in the snow. (See Figure #19)
- I TREES- Recommend trimming tree limbs located around the electrical service drop. (See Figure #20)

GUTTER- Down spout located on the SE corner of home was off/disconnected and laying in the snow.

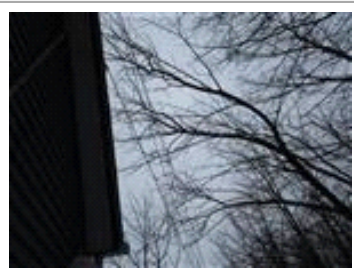
Figure Number 20

TREES- Recommend trimming tree limbs located around the electrical service drop.

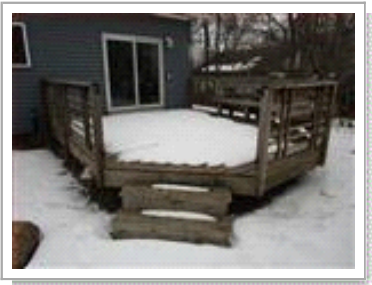
Figure Number 21

- I DECK- The deck is rated as marginal due to age of wood, some deterioration and decay was present, no structural deficiencies were observed. (See Figure #21) (See Figure #22)

DECK- The deck is rated as marginal due to age of wood, some deterioration and decay was present, no structural deficiencies were observed.

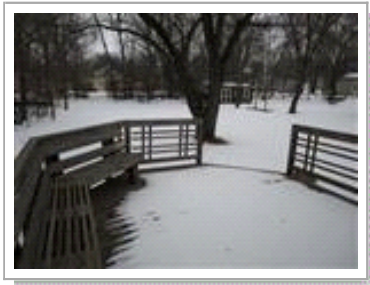
Figure Number 22

DECK- The deck is rated as marginal due to age of wood, some deterioration and decay was present, no structural deficiencies were observed.

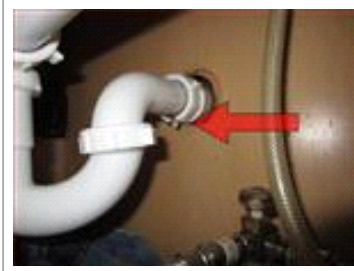
Figure Number 35

- I PLUMBING- Kitchen sink faucet has a slow drip/broken sprayer and the drain inside the base cabinet has a leak at a compression fitting when in use, repairs are needed. (See Figure #35) (See Figure #36)
- I HEATING- The heat duct for the upper east bedroom was not functional at time of inspection. Ducting is suspected to have been altered/removed when the newer larger patio door was installed, evidence of this was found in the basement. (See Figure #42) (See Figure #43)
- I BATHROOM- Handle for the shower lever was broken/damaged, shower can be operated using a pliers to lift valve. (See Figure #47)

PLUMBING- Kitchen sink faucet has a slow drip/broken sprayer and the drain inside the base cabinet has a leak at a compression fitting when in use, repairs are needed.

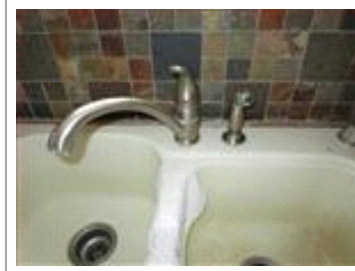
Figure Number 36

PLUMBING- Kitchen sink faucet has a slow drip/broken sprayer and the drain inside the base cabinet has a leak at a compression fitting when in use, repairs are needed.

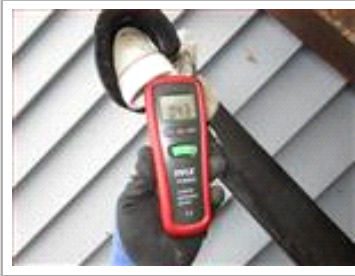
Figure Number 37

- I ELECTRICAL- Kitchen countertop receptacles should be ground fault protected (G.F.C.I.) for safety.
- I HEATING- The average life expectancy for a furnace is 20-25 years, this unit is 8 years old. Unit is rated as marginal due to a slightly high level of carbon monoxide testing at the exhaust flue located on the rear exterior of home approximately 43 ppm. Recommend a further evaluation by a qualified HVAC technician to ensure safe operation of appliance. (See Figure #37)

HEATING- The average life expectancy for a furnace is 20-25 years, this unit is 8 years old. Unit is rated as marginal due to a slightly high level of carbon monoxide testing at the exhaust flue located on the rear exterior of home approximately 43 ppm. Recommend a further evaluation by a qualified HVAC technician to ensure safe operation of appliance.

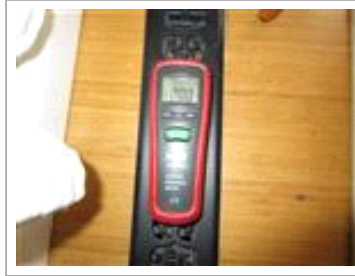
Figure Number 38

A carbon monoxide test was performed at random registers throughout the home and zero PPM (parts per million) was detected. It should be noted that cracks and broken welds in the heat exchanger may not always be detected.

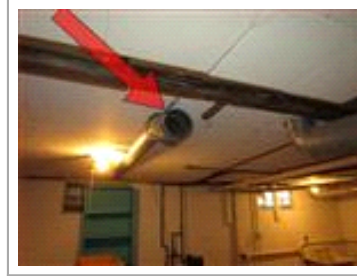
Figure Number 42

HEATING- The heat duct for the upper east bedroom was not functional at time of inspection. Ducting is suspected to have been altered/removed when the newer larger patio door was installed, evidence of this was found in the basement.

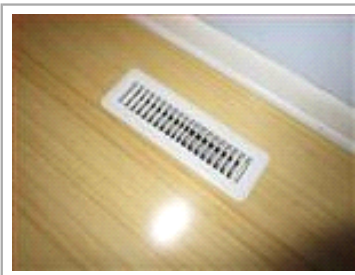
Figure Number 43

HEATING- The heat duct for the upper east bedroom was not functional at time of inspection. Ducting is suspected to have been altered/removed when the newer larger patio door was installed, evidence of this was found in the basement.

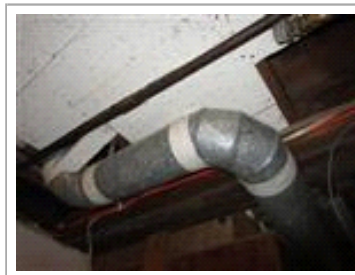
Figure Number 44

It should be noted that thin insulation around ductwork in basement likely contains asbestos, do not disturb this material without testing.

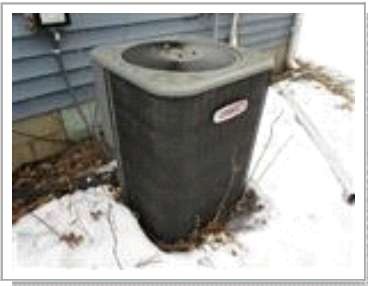
Figure Number 45

The average life expectancy for the air conditioning system and its components is 20-25 years, this unit is approximately 16 year(s) old. Industry standards indicate if the ambient temperature is below 65 degrees the a/c system can not be tested. This is due to the viscosity of the oil in the compressor may cause damage to the unit, a visual inspection was performed.

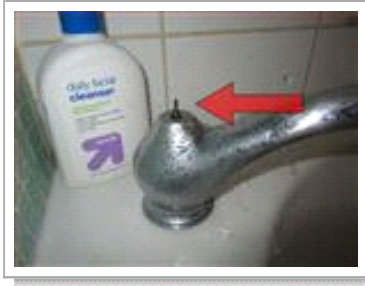
Figure Number 47

- I Image of room. (See Figure #46)
- I BATHROOM- Handle for the shower lever was broken/damaged, shower can be operated using a pliers to lift valve. (See Figure #47)
- I See Summary Remarks

BATHROOM- Handle for the shower lever was broken/damaged, shower can be operated using a pliers to lift valve.

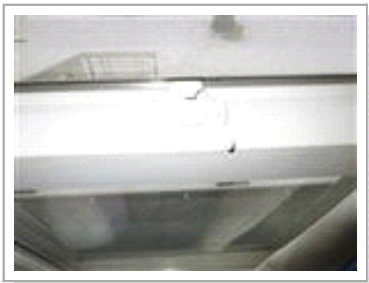
Figure Number 60

Rear window did not clasp shut when operated.

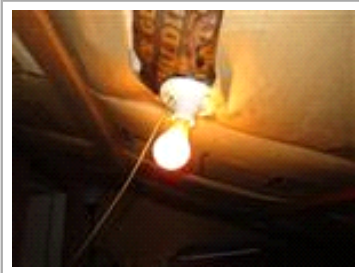
Figure Number 68

Ceiling light needs a cage around fixture.

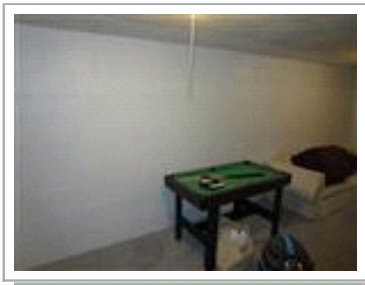
Figure Number 71

Remarks	I The west foundation wall has evidence of minor inward bowing. This appears to have been caused from the earth applying hydrostatic pressure against the foundation subsequently causing it to move. At this point movement appears to be older and cracks have been filled and painted. Recommend monitoring for further movement, if cracking or movement persists contact a qualified building contractor for repairs. (See Figure #71) (See Figure #72)

The west foundation wall has evidence of minor inward bowing. This appears to have been caused from the earth applying hydrostatic pressure against the foundation subsequently causing it to move. At this point movement appears to be older and cracks have been filled and painted. Recommend monitoring for further movement, if cracking or movement persists contact a qualified building contractor for repairs.

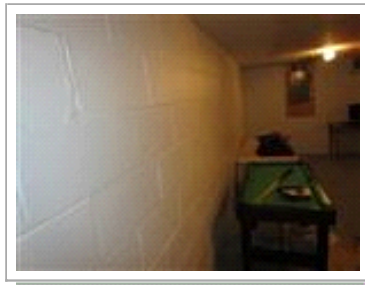
Figure Number 72

The west foundation wall has evidence of minor inward bowing. This appears to have been caused from the earth applying hydrostatic pressure against the foundation subsequently causing it to move. At this point movement appears to be older and cracks have been filled and painted. Recommend monitoring for further movement, if cracking or movement persists contact a qualified building contractor for repairs.
