Premier Property Inspections

Pre Inspection
809 Linden St
Northfield , MN 55057

Date of Inspection: 2/18/2022

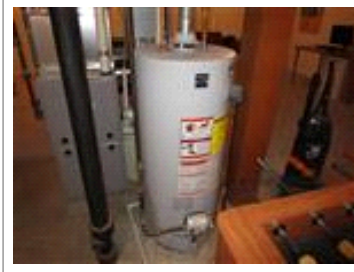
Figure Number 29

The average life expectancy for the hot water heater is 10-15 years, this unit is 8 year(s) old.

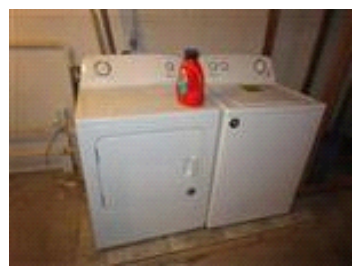
Figure Number 34

Image of the washer and dryer, a cycle was ran through the units however its difficult to determine the effectiveness of appliances.
