Premier Property Inspections

Pre Inspection
809 Linden St
Northfield , MN 55057

Date of Inspection: 2/18/2022

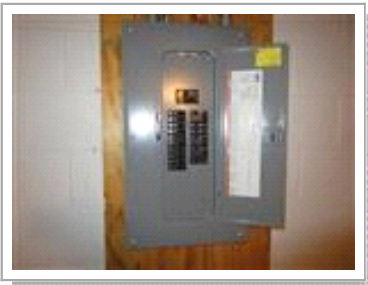
Figure Number 23

Testing of the circuit breakers and load calculations is outside the scope of this inspection.

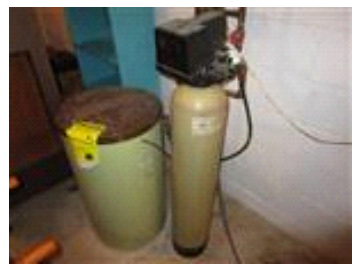
Figure Number 28

Water softeners are outside the scope of this inspection.

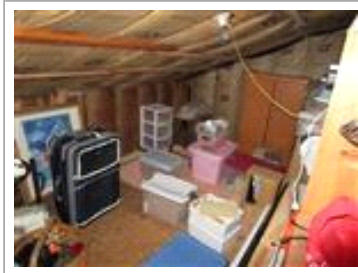
Figure Number 69

Image of attic space.

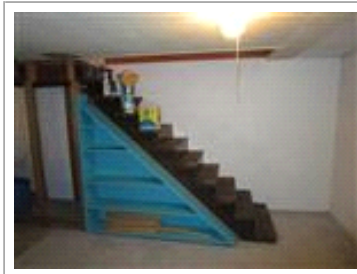
Figure Number 77

- I BASEMENT- Stairwell lacks a hand/guard rail. (See Figure #77)

BASEMENT- Stairwell lacks a hand/guard rail.
